TN NO: N-1655

A 20-KW WIND ENERGY CONVERSION SYSTEM

(WECS) AT THE MARINE CORPS AIR STATION,

KANEOHE, HAWAII

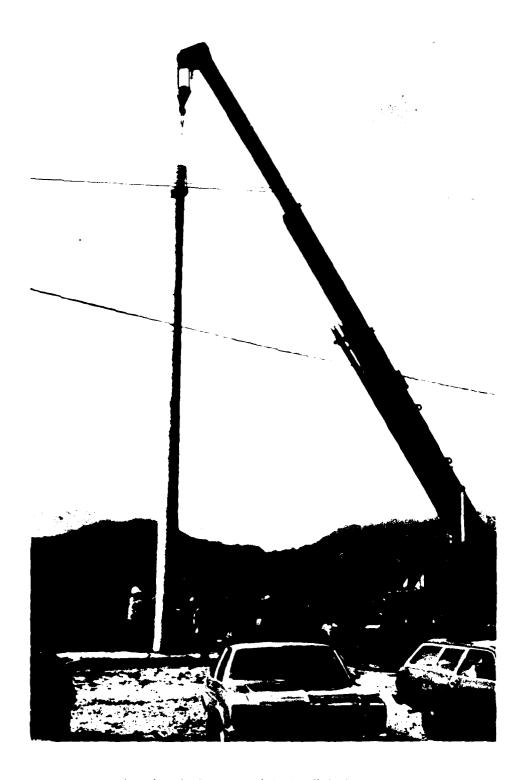
- 8. Ease of installation. Installation of the WECS generator required use of cranes and specialized crews (Figure 20). The grouting of the tower in the foundation is shown in Figure 21 (the tower is wedged in place for a quick setting grout). Although specialized installation equipment and personnel are generally available at most facilities, installation of the hub assembly is a relatively complex and time consuming matter (Figure 22).

Figure 20. The WECS tower being installed using a crane.
